Manhole Inspection Summary

Manhole # S25A__003MH

Insp Date: **8/20/07 9:12 AM**

Location Address: **1208 EDMONDSON AVE**

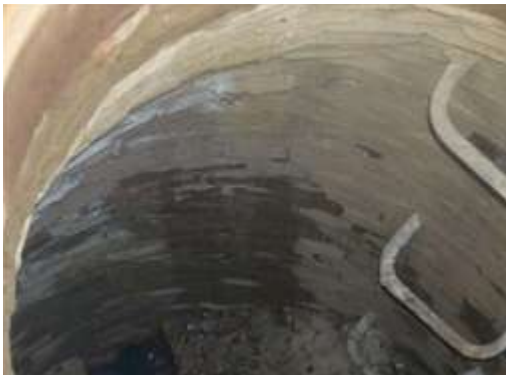
Defect 2

Infiltration: ☐ None ☐ Joint ☐ Cracks ☐ Mortar ☐ Roots ☒ **Wall**

BARREL INFILTRATION

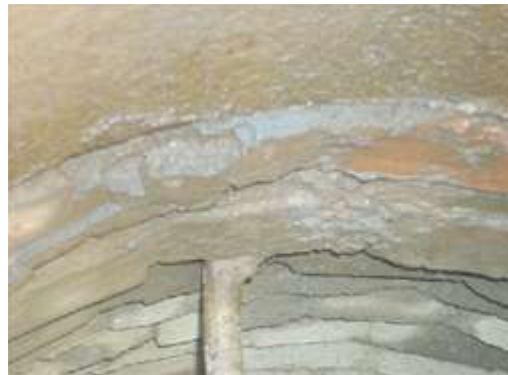
Defect 1

Condition: ☐ Sound ☐ Cracked ☐ Root Intrusion ☐ Loose Brick ☒ **Deteriorated**

DETERIORATION OF CHIMNEY

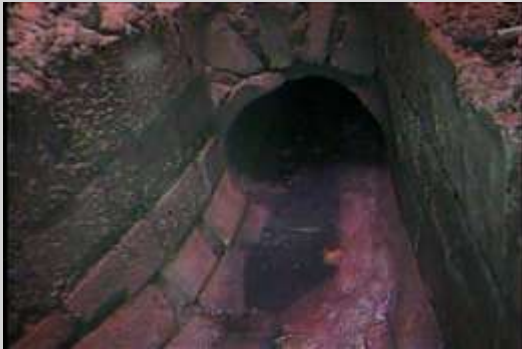
12 O'Clock Outflow

8 in. Circular Gravity Sewer
Pipe Out @ 12 O'Clock

Pipe Height: **7.2** (in.) Rod and Bar (Angled)
Pipe Material: **Clay** ☐ Pipe Lined
Invert Depth: **9.89** (ft.) Flow Characteristics: **Slow**
Deposits: ☒ None ☐ Mud ☐ Sludge ☐ Debris ☐ Grease
Silt Depth: (in.) Deposits Extent:
Infiltration: **None** Pipe Seal Cond: **Broken**

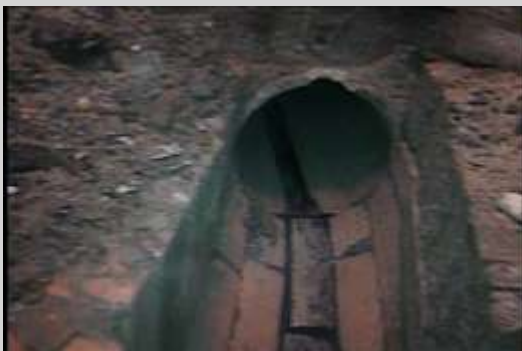
5 O'Clock Inflow

8 in. Circular Gravity Sewer
Pipe In @ 5 O'Clock

Pipe Height: **8.4** (in.) Rod and Bar (Angled)
Pipe Material: **Clay** ☐ Pipe Lined
Invert Depth: **9.54** (ft.) Flow Characteristics: **Slow**
Deposits: ☒ None ☐ Mud ☐ Sludge ☐ Debris ☐ Grease
Silt Depth: (in.) Deposits Extent:
Infiltration: **None** Pipe Seal Cond: **Broken**
